Metallurgy for Industries

July, 2016

Use of ultrasonic inspection for creep detection

*A case study***Introduction :**

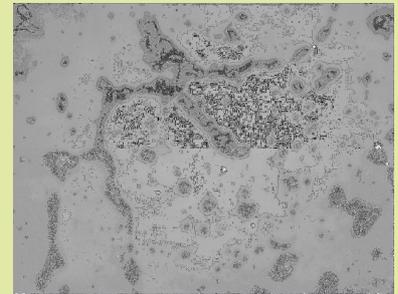
**Magnification:** 400X**Etchant:** - Kallings**MOC:** HP Modified**Component:** Reformer tube**Cause:** Creep damage

Useful hints: Replicated microstructure is showing presence of intergranular aligned cavities at the eutectic carbides indicating creep damage. Secondary carbides appear to have coarsened and tendency to migrate towards primary carbides.

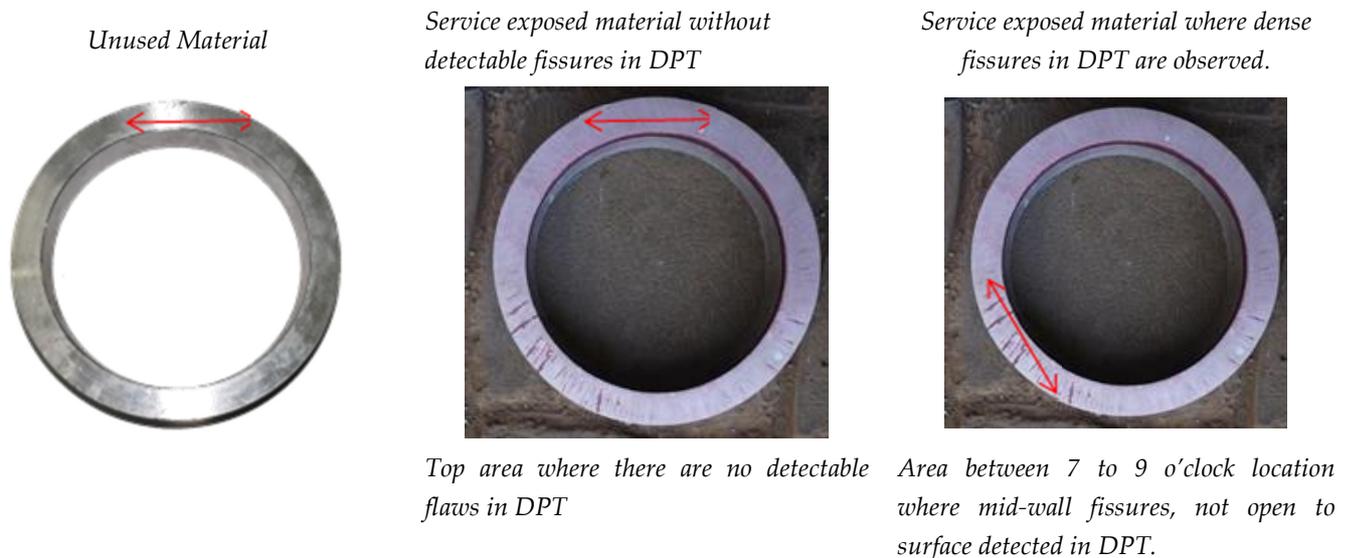
Comparison between two samples shows difference in attenuation behaviour. The first sample is from an unused (new) tube, that was never exposed to service. The second sample is drawn from the reformer tube which is exposed to service with severe service degradation. However, it is local at one orientation where DPT (dye penetration test) detected mid-wall fissures and area away from it was found to be free from any detectable indication in DPT.

The images below show experimental data on visual appearance, microstructure at relevant location and corresponding ultrasonic attenuation pattern for the three tubes.

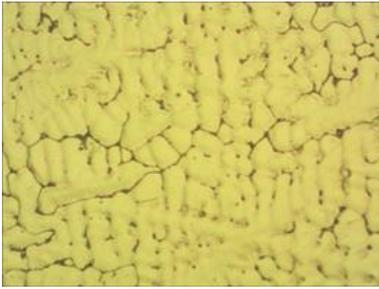
OD surface microstructure of new material showing primary carbides and fine precipitated secondary carbides within austenite matrix. (100X)

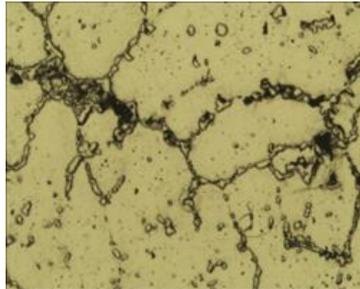
OD surface microstructure shows presence of aligned creep voids having tendency to form micro cracks at primary carbides (100X)

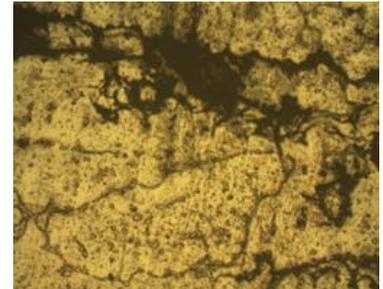
OD surface microstructure showing visible creep fissures with presence of wide, parallel micro cracks. (100X)

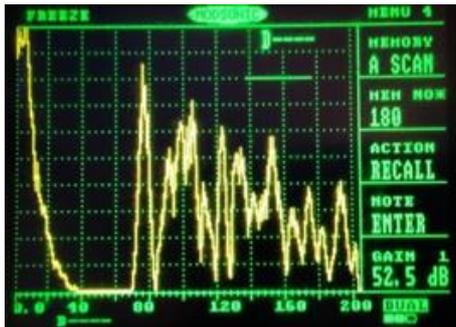
Ultrasonic pattern for unused sample

The received echo is adjusted at 80% FSH and the required dB for that is noted. The comparison between ultrasonic attenuation shows a difference of 6dB between the unused tube and used tube where there are no indications of flaw in DPT but microstructure clearly shows the aligned creep voids. In case of the used sample having mid-wall fissures, it is not possible to set the echo 80%FSH indicating complete loss of sound energy.

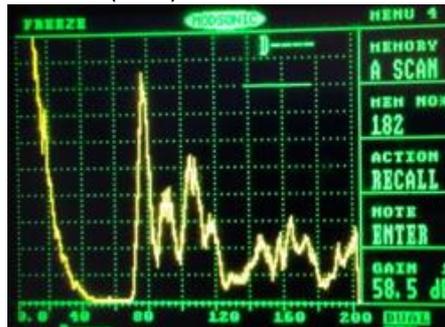
Ultrasonic pattern where no detectable flaws in DPT.

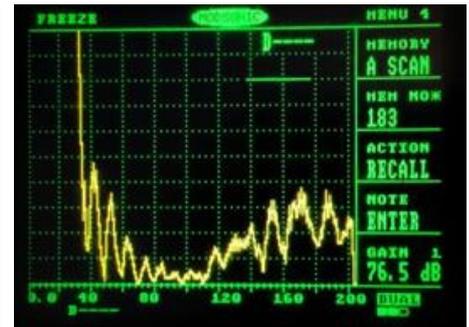
Ultrasonic pattern at mid-wall fissure area.

The above demonstration clearly establishes that the ultrasonic attenuation technique can reveal the mid-wall fissures. Further, coupled with the microstructure study it is possible to correlate the presence of voids and in turn the creep damage using this technique.
