Metallurgy for Industries

A Monthly News Letter

January, 2016

The mechanism of fatigue failures

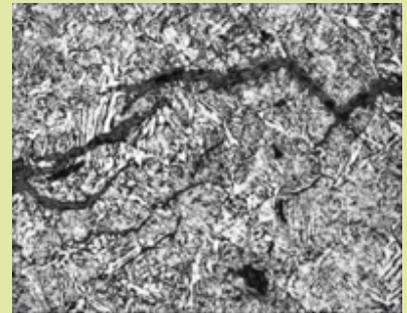
Microstructure of the Month

**Magnification:** 400X**MOC:** ASTM A 516 Gr 70**Component:** weld joint of nozzle and pipe or reboiler**Observation:** Optical microscope image of weld indicates typical SCC filled with oxide scales.**Cause:** The cracking at weld and HAZ region is on account of caustic stress corrosion cracking; substantiated by higher amount of sodium found in EDS analysis.**Useful hint:** inadequate cleaning of component before the plating process can lead to poor adhesion in metallic coatings. It is advised to carry out precise hardness evaluation on weld and HAZ areas to find susceptibility of SCC. Areas having significant difference in hardness values between base metal to HAZ or weld should be subjected PWHT at an available opportunity.

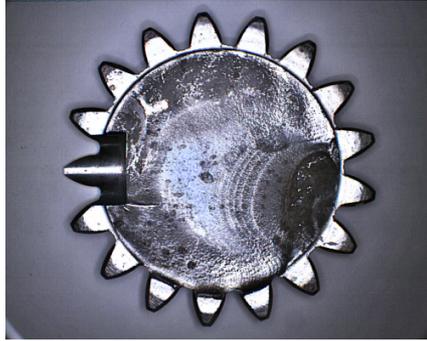
Low magnification view showing convex beach marks on fracture surface.

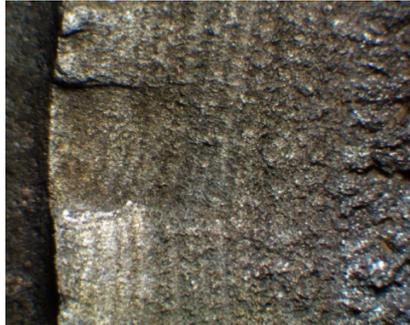
Low magnification view showing ratchet marks at fracture edge

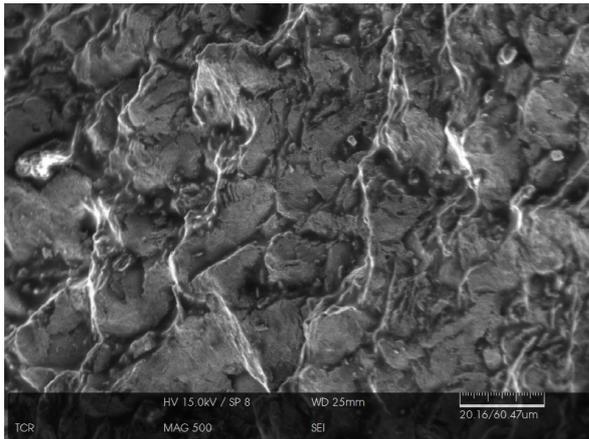
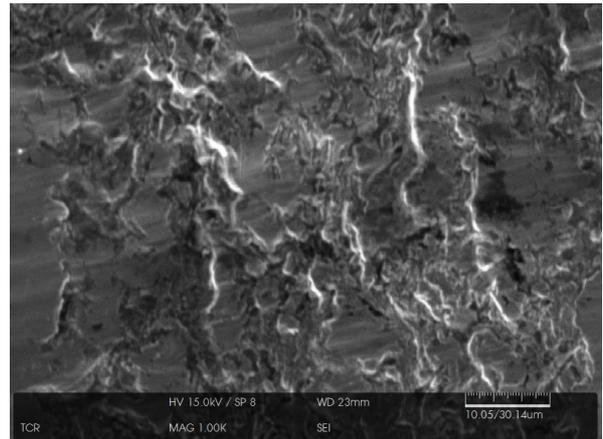
SEM images of fracture surface showing fatigue striations
