Metallurgy for Industries

July, 2016

Use of ultrasonic inspection for creep detection

*A case study***Introduction :**

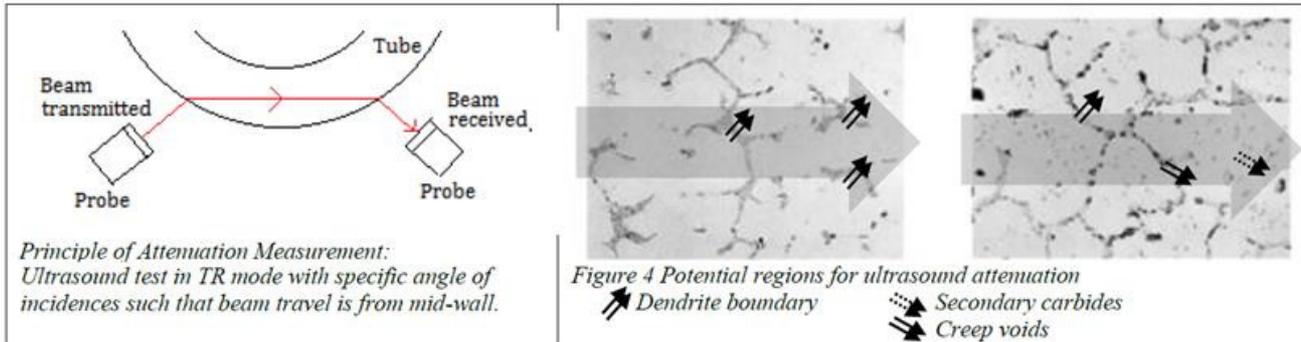
received by sensor at the other end. The energy transmitted is given by the difference between incident energy and the energy lost mostly in the form of beam scatter. The following figures illustrate the same.

The ultrasounds when passed through randomly oriented creep voids; aligned creep voids or intermittent micro cracks, refract and attenuate the energy because of impedance mismatch. However, creep cracks (such as fissures) significantly attenuate the energy and lead to loss of signal.
