Metallurgy for Industries

A Monthly News Letter

In situ Metallography

A Powerful NDT tool for health Assessment

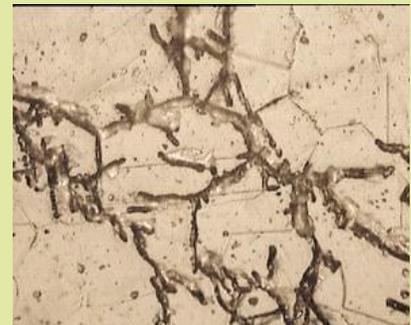
Microstructure of the Month

Magnification: 400X

Etchant: 10% Ammonium Persulphate

MOC: ASTM A 240 Gr 316L

Observation: Microstructure shows fine-grained worked austenitic structure with twins. No carbide precipitation is observed along the grain boundaries. Presence of heavy trans-granular SCC crack is observed.

Cause: The onset of TGSCC seems to be from Chloride attack on account of chloride found in EDS analysis.

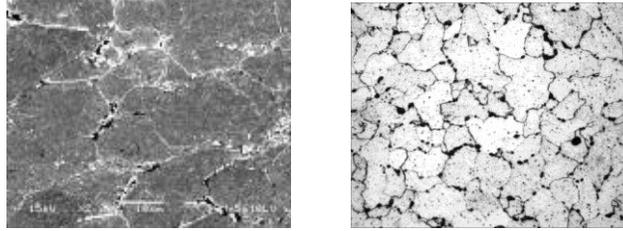
Creep Damage

Time related, temperature dependent deformation under stress is known as creep. The degradation is stage wise and it can reveal the initiation in the microstructure as creep voids, orientation of creep voids and micro cracks.

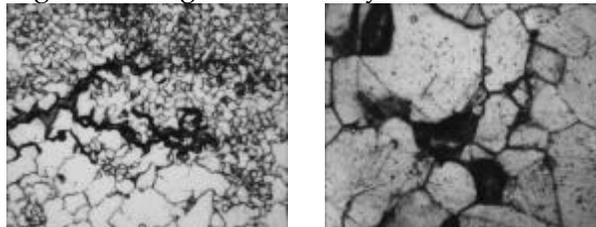
Intergranular Corrosion

The weakening of the grain boundary takes place due to preferential corrosion on account of deposition of chromium carbides. Depletion of chromium takes place in the vicinity where the corrosion resistance drops drastically in a highly localized region of the grain boundary.
